## Local surface deformation of 2018 Hokkaido Eastern Iburi earthquake detected by ALOS-2 SAR

Satoshi Fujiwara, Takayuki Nakano, Yu Morishita, Tomokazu Kobayashi, Hiroshi Yarai, Hiroshi Une, and Kyonosuke Hayashi Geospatial Information Authority of Japan fujiwara-s2vq@mlit.go.jp

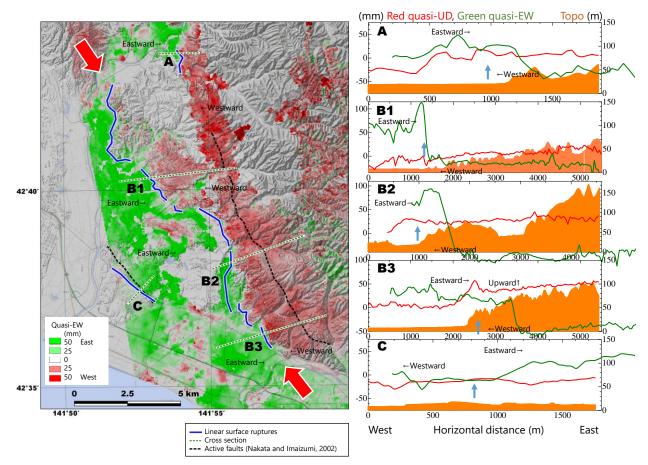
The linear surface ruptures are derived from linear phase discontinuities and/or offsets showing displacement in the interferograms of ALOS-2 SAR. From Atsuma to Mukawa town, the linear surface ruptures showing east-west shortening extend for about 15 km in the direction of NNW –SSE. The linear surface ruptures have following features:

- ✓ Displacement amount of east-west shortening is about 5 cm to 10 cm.
- $\checkmark$  Vertical displacement is rather small.
- ✓ The displacement along the linear surface ruptures can be described as reverse fault motion with extremely low dip angle.
- ✓ Since there is a certain distance from the linear surface ruptures to the aftershocks, it is questionable whether they directly connect to the main earthquake fault or not.
- ✓ The strike and displacement (reverse fault of east-west shortening) is harmonious with the surrounding topography and tectonics, but they have not been recognized as active faults.
- $\checkmark$  These linear surface ruptures exist on the SSE extension of a major fault zone.

From these circumstances, the linear surface ruptures are likely secondary fault motion passively generated by the Hokkaido Eastern Iburi earthquake appeared near the surface of the earth.

Fig. 1 Linear surface ruptures detected by InSAR images Left Detected linear surface ruptures and quasi-EW displacement by 2.5D method Right Cross sections of the ruptures
