# Visit to the Monuments of the Nankai Earthquake

UJNR06 Excursion Guide (November 8, 2006)

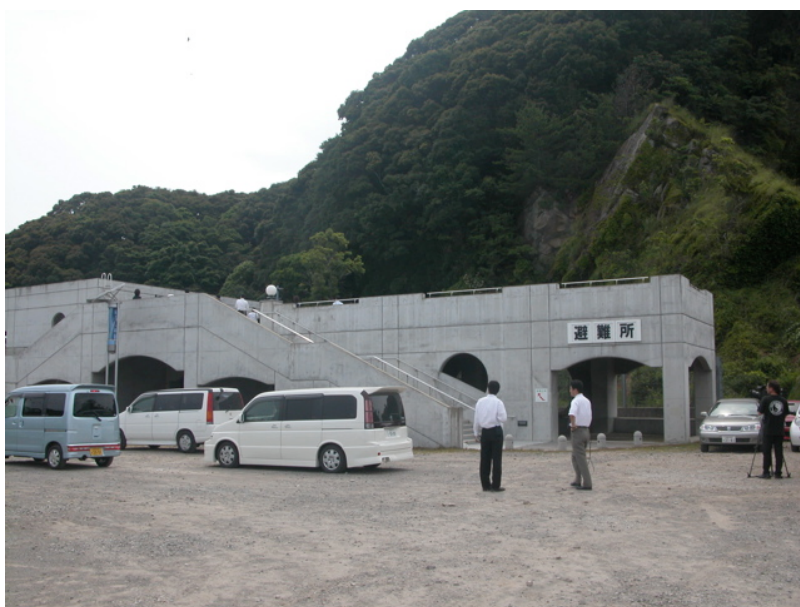
Fig.1 Tsunami shelter, Sange district

This new tsunami shelter in the northern part of the Sange district provides a refuge to which all residents and workers in the Sange district may evacuate before the arrival of a tsunami. The new refuge also solves the problem of overcrowding on the road to the existing refuge on the hill.

On the basis of previous tsunamis, the height of the new shelter is sufficient to survive a 5 m tsunami and 1 m of coseismic land subsidence.

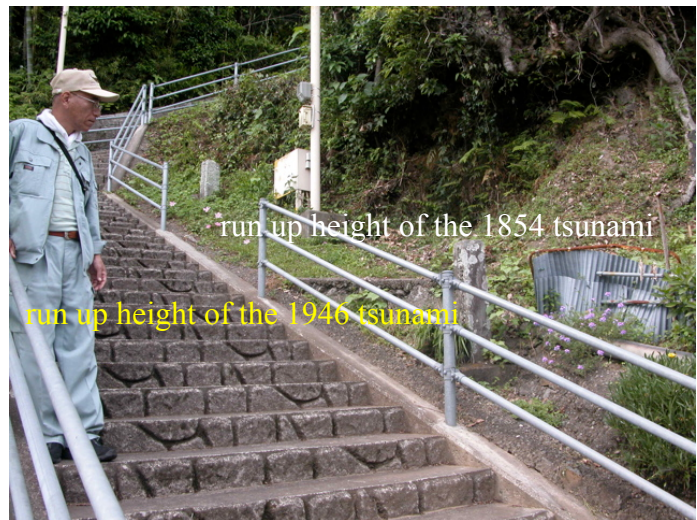
Fig.10 The highest points of the runup tsunamis near the Kannondo temple

ing the stone steps, one comes to monuments of the 1854 *Ansei-Nankai* earthquake and the 1946 *Showa-Nankai* earthquake, which show the highest points reached by the tsunami waves. Looking at them, one can image the scale of the tsunami at the time of these earthquakes.

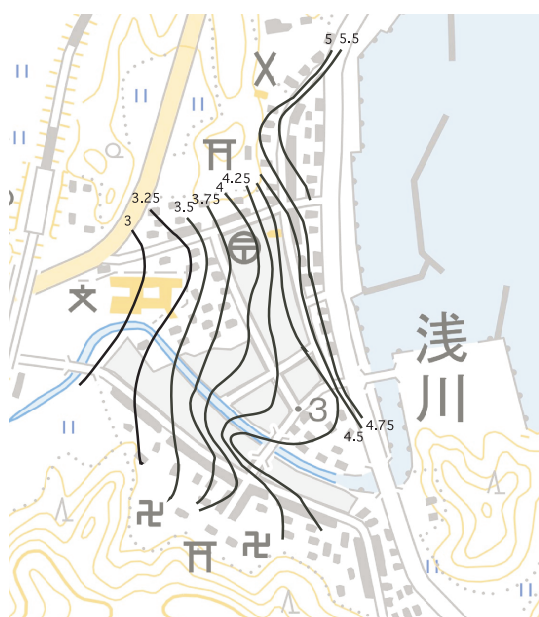
Fig.16 Maximum flooded height distribution relative to sea surface

Figure 16 shows the maximum flooded height distribution of the *Nankai* earthquake. The height flooding increased where the mountains approach the coast, and it decreased inland. An iso-

water line stretches upstream of the mouth of the river, and then the iso-water line becomes dense. A tsunami flowed into the Urakami River and raised the water level, and the surface of the water inclined suddenly, and then a bridge was washed away.

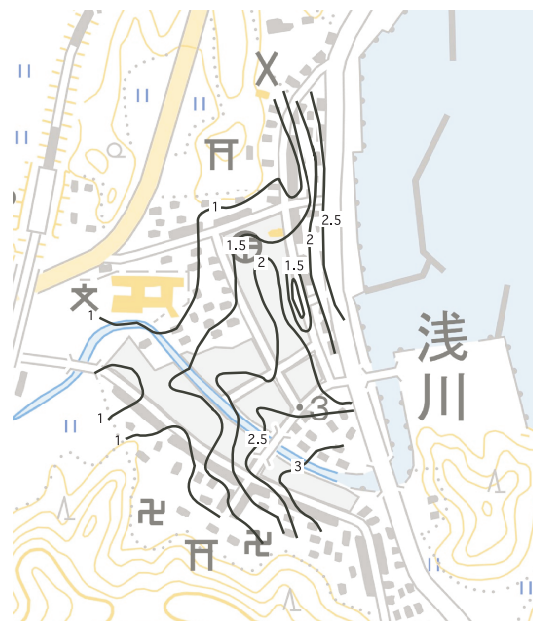
Fig.17 Height of flooding from the ground

Figure 17 shows the height of flooding from the ground. In the Urakami River mouth, we recognize that the depth of flooding reached 2.5 to 3.0m.

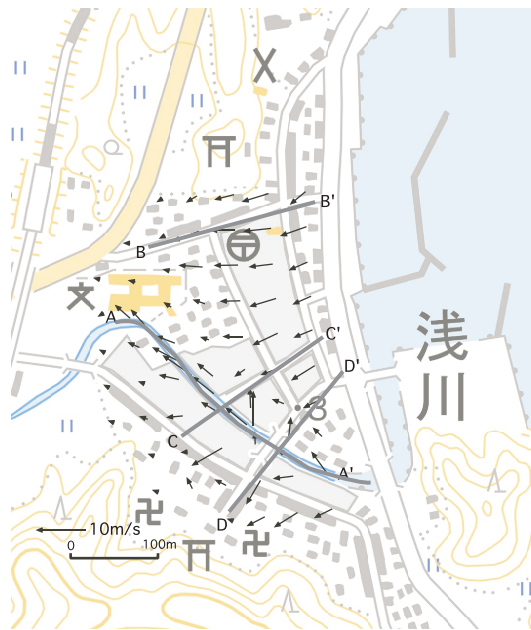
Fig.18 Velocity distribution of tsunami flow

Figure 18 shows the direction and speed of the flow of the tsunami that flooded the center of a village. The tsunami progressed inland from the shore. Then, it flowed into the Urakami River and flooded the land around the river. Then it joined the inshore flow and drifted toward the upper reaches of the Urakami River. Finally, the flow slackened in the vicinity of an elementary school, and many items washed away by the tsunami accumulated there.
